Visual Analysis and Phased Interpretation of Chantry Chapel, Wakefield

Joanne Harrison¹

¹ Department of Archaeology, University of York, The King's Manor, York, YO1 7EP

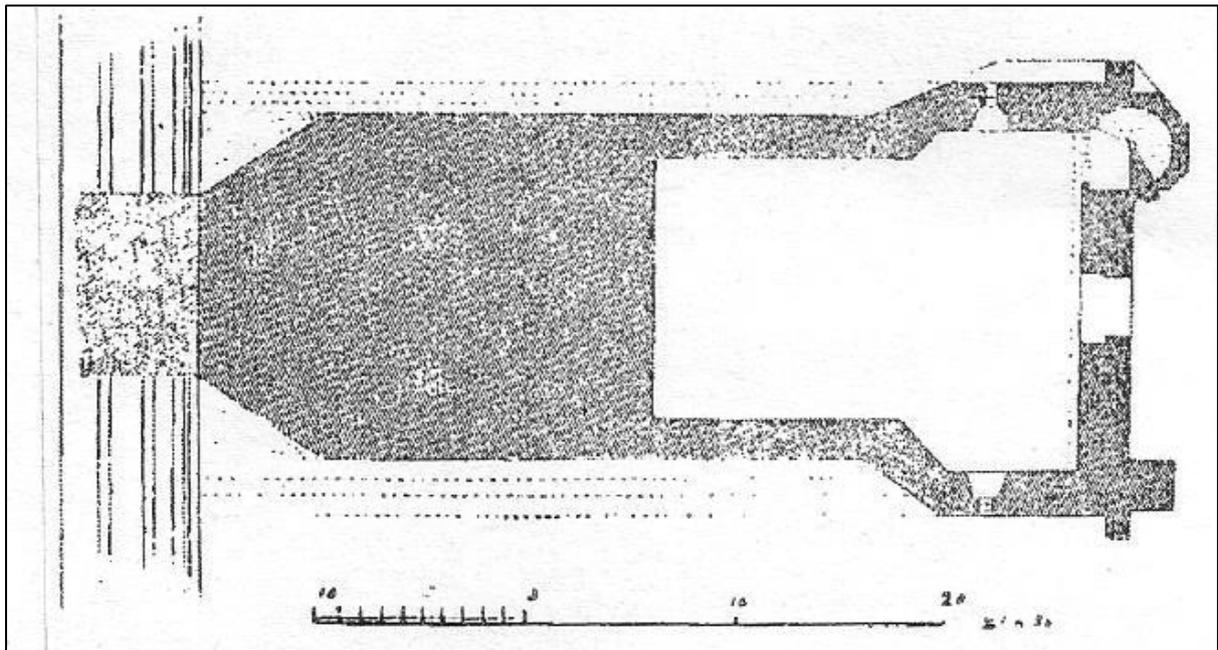
Figure 2. (above) Plan of the Crypt (Walker 1967, 233).

The sandstone building stood on a small island in the River Calder, adjoining Wakefield Bridge. It measured 50' long by 25' wide by 36' high and contained two rooms – a crypt or sacristy at lower level, and a chapel above. Internally, the chapel measured 42' long by 16'8" wide and the crypt, under the eastern third of the building only, measured 16' wide. An octagonal turret to the

The crypt area at the lower level shows evidence of numerous periods of change including formation of a chimney, the remains of a fireplace, and plumbing and electrical services. It also appears that the crypt has been reduced in size as the plan (figure 2) does not correspond to the current layout. Stone infill is evident, however there is no documentary evidence to explain this. The room does not have a use.

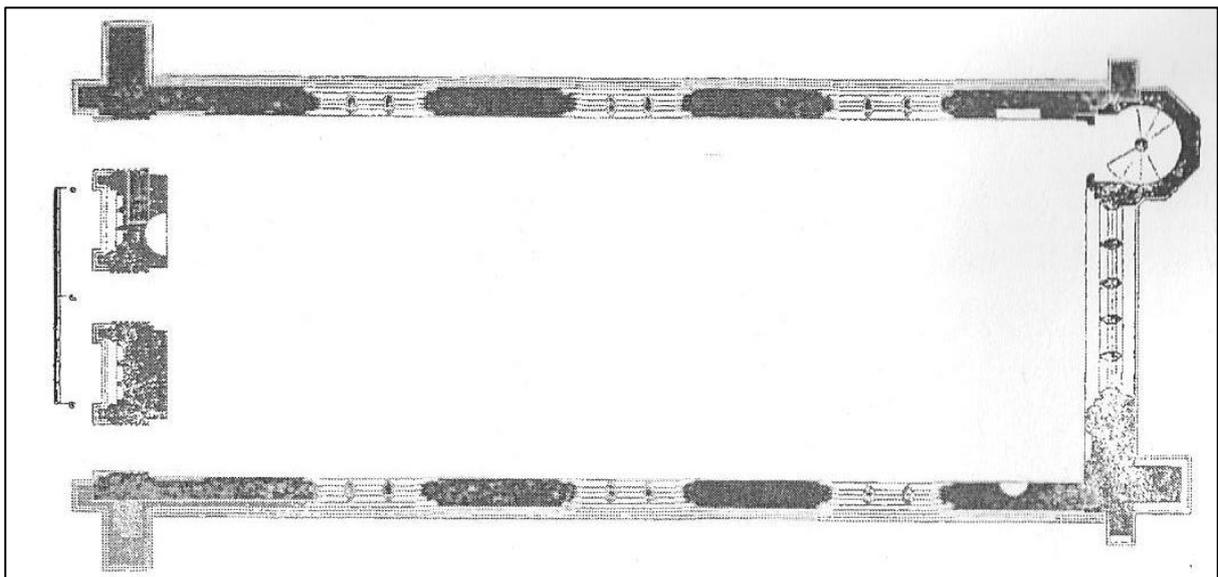
Figure 3. (above) Plan of the Chapel (Walker 1967, 235).

Internally, a holy water stoup sat in a recess in the west wall, to the north of the central door. In the north wall, a recess with doors served as an aumbry, and against the south wall was a piscina. On the east wall, a statue of the Virgin Mary was positioned in a recess, and in front of this was a raised stone altar (Walker 1967, 238).

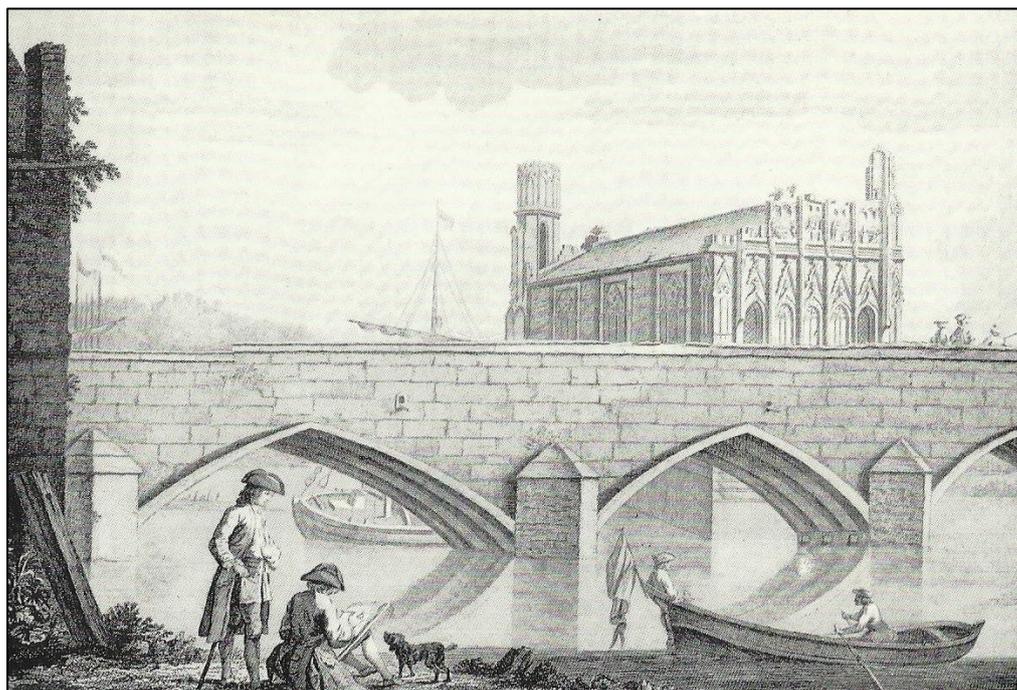
Figure 6. Drawing dating from 1783 (Speak and Forrester 1971, 37) showing the chapel's decayed west front.

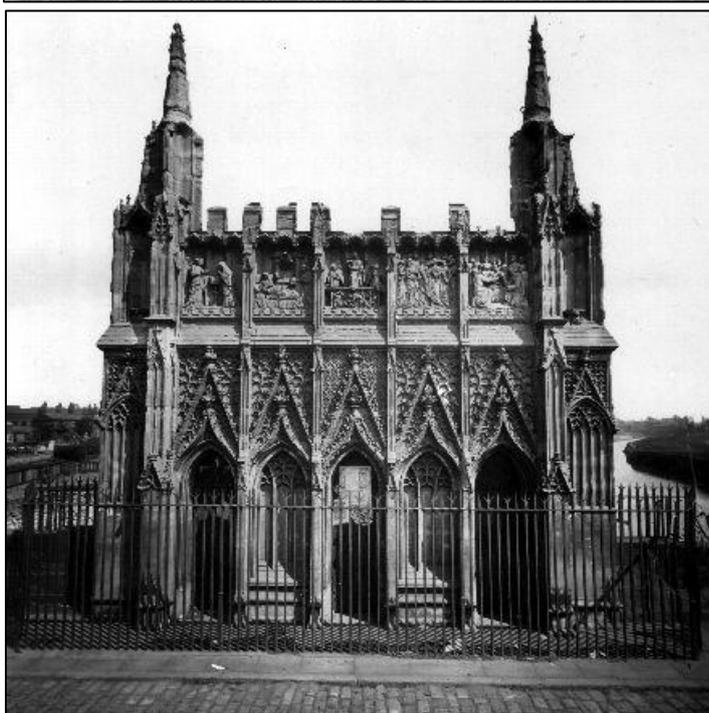
Figure 8. The West front between 1895-1905 with the protective railings in place. Missing stonework can already be seen to the top crenellations (Garratt 1895-1905 [Photograph: Accession number: 1983.157] At <http://www.wakefieldmuseumcollections.org.uk>). Image courtesy of Wakefield Council.

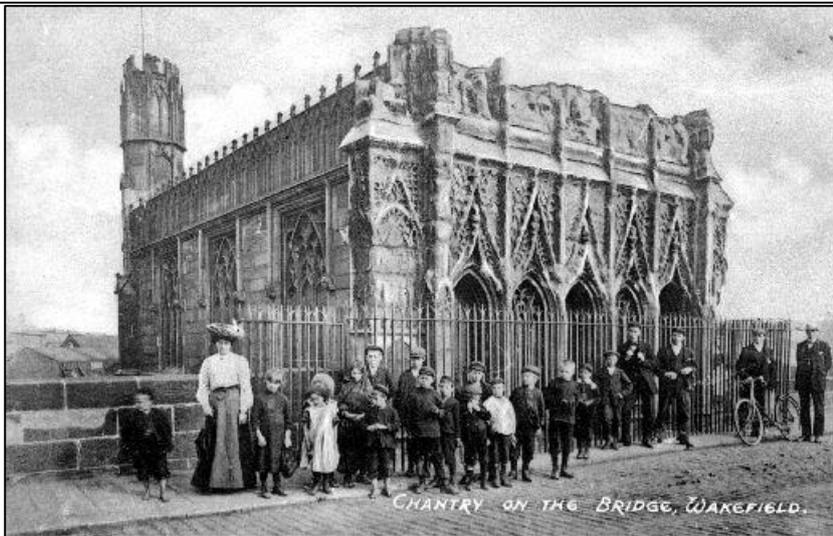
Figure 9. The Chapel between 1900-1910. The severe decay to the front is not evident on the previous photograph. Even if the photographs were taken 15 years apart the change seems very dramatic. (Anon. 1900-1910 [Photograph: Accession number: 1978.104/5] At <http://www.wakefieldmuseumcollections.org.uk>). Image courtesy of Wakefield Council.

Unfortunately, Caen and Bath stone were not suitable for use in an industrial town and the front façade rapidly deteriorated to a condition worse than the original it had replaced (Walker 1967, 246).

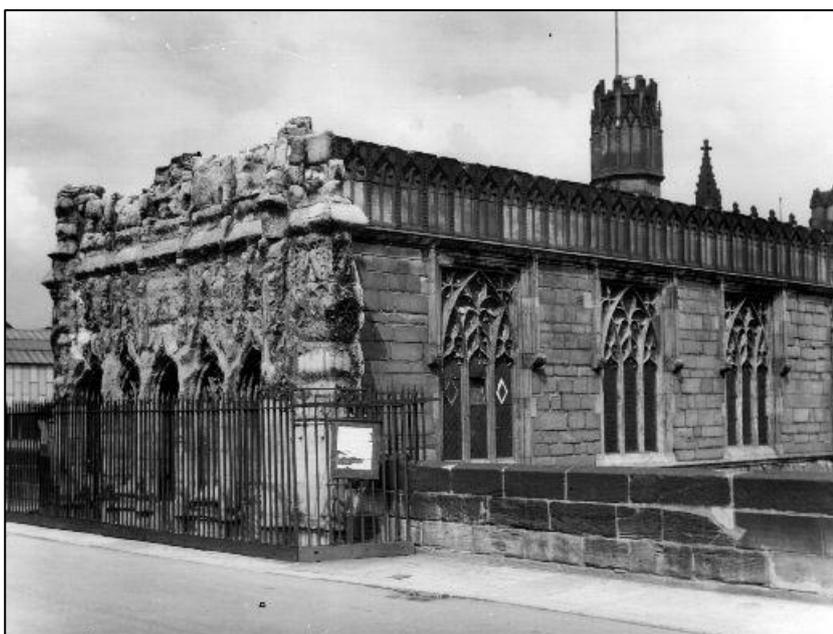
Figure 10. Dated between 1910-30, further erosion can be seen, particularly to the north side of the façade (Anon. 1910-30 [Photograph: Accession Number: 1993.2034] At <http://www.wakefieldmuseumcollections.org.uk>). Image courtesy of Wakefield Council.

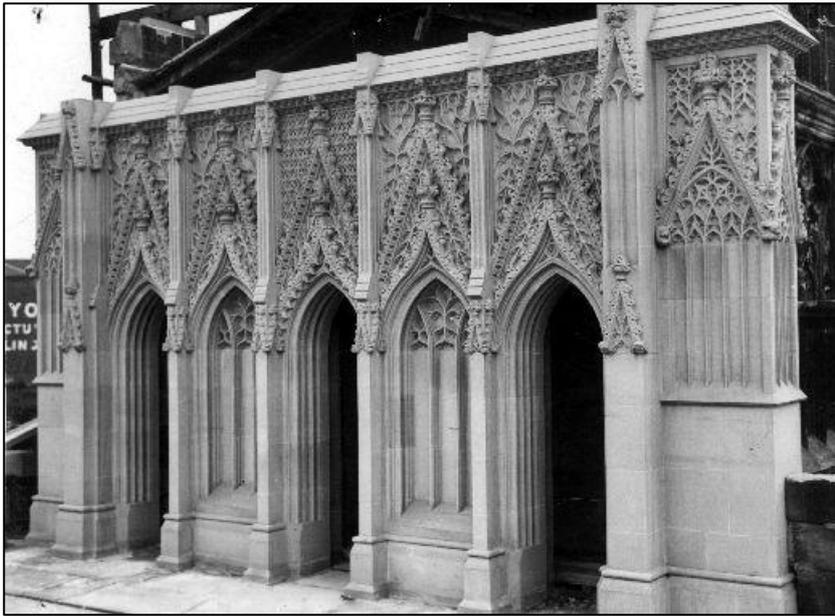
Figure 11. Erection of the new front in the same design as the previous front. (Anon. 1930-40 [Photograph: Accession Number: 1971.59/8] At <http://www.wakefieldmuseumcollections.org.uk>). Image courtesy of Wakefield Council.

The first major restoration of the Chapel in the 20th century was carried out in 1939 under the guidance of the architect Sir Charles Nicholson. The west front was replaced, and, according to Walker (1967, 247), so also were miscellaneous stones and most of the window mullions and tracery, and the existing walls repointed. Taylor (2012, 37) reported that the statues to the west front were added in 1948 after World War II had ended, yet photographic evidence of apparently later date does not show them. Primary documentary sources do however confirm that further works were required by 1948 and that between 1950 and 1954, a programme of works was carried out under the guidance of the architect Major Pace. This included new stonework for two windows, repairs to the roof, external and internal pointing, replacement of the chapel floor/crypt ceiling, an upgrade to heating, lighting and power systems and miscellaneous minor works (Secretary's Reports to AGM 25/4/1949, 4/4/52, 13/4/53 and 1955. WYAS, D152; Letters from Pace 7/4/52, 18/8/52 and drawings nd. WYAS, D152). It seems unlikely that replacement of the

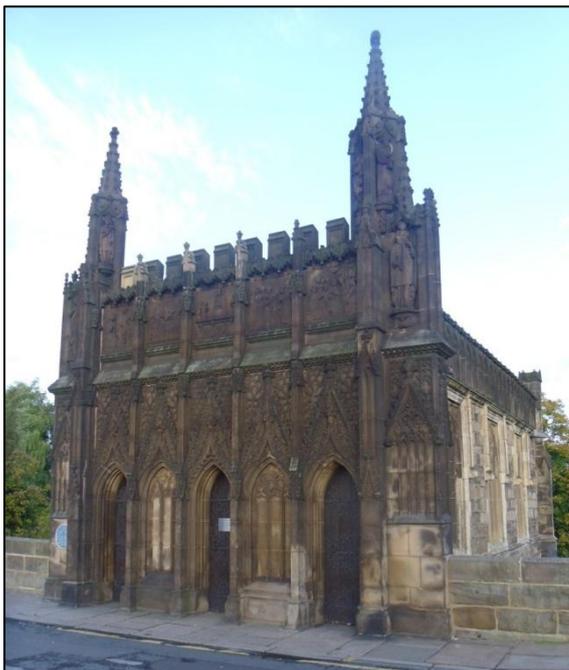
The front façade facing the bridge is very soiled and weathered, and is a stark contrast to the other elevations which are much cleaner. Evidence of stone replacement is very clear to see,

because of the lesser amount of dirt and the reduced level of decay. The condition of the older stone is quite variable, with some retaining good clarity to the highly decorative designs, and other areas severely eroded. Documentary research has provided dates for some of the replacement works, alongside information about design choices and specification.

Figure 12. The facade today, much weathered and dirtied by passing traffic, and with small areas of stone replacement evident (authors own).

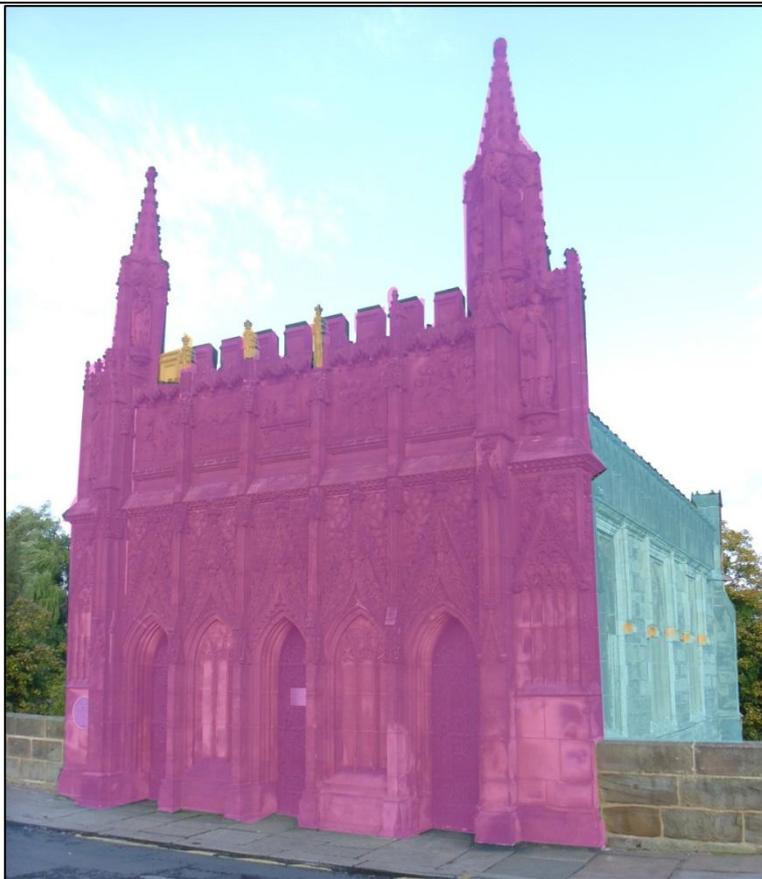
There have been three major phases - the original building, rebuilding of the chapel from bridge level upwards in 1847, and the second replacement of the front in 1939 (Pevsner and Radcliffe 1967, 530), but there also have been numerous alterations, repairs and modernisations throughout its life. The figures below describe the external phasing.

- Key**
- Medieval (14th-17th centuries)
 - 18th-19th century major works
 - 20th century major works
 - 20th-21st century minor works

Figure 13. West elevation photographic phasing diagram (authors own).

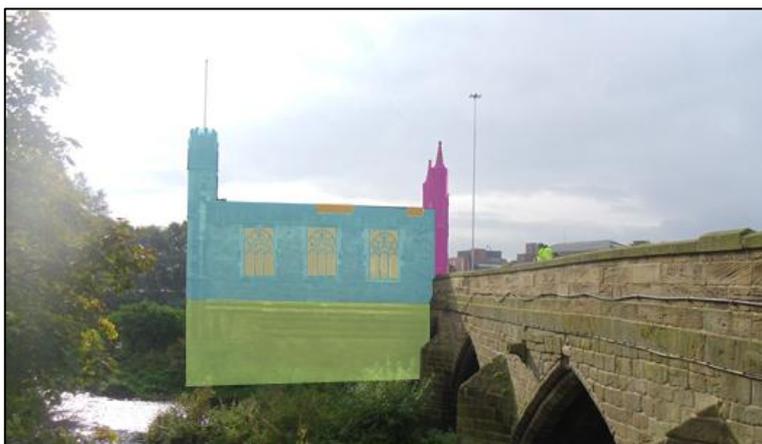
Figure 14. North elevation photographic phasing diagram (authors own).

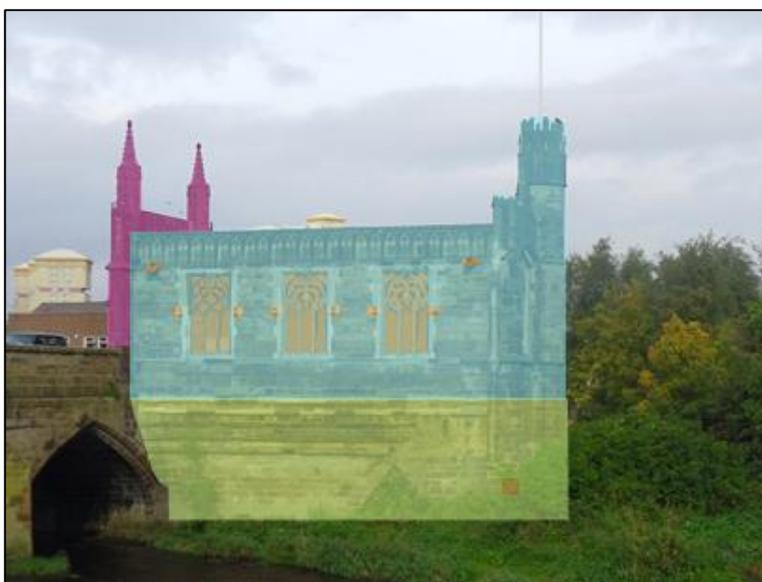
Figure 15. South elevation photographic phasing diagram (authors own).
