1 Hungate: The New Jorvik?

Charlotte Burford (<mailto:cbl511@york.ac.uk>)

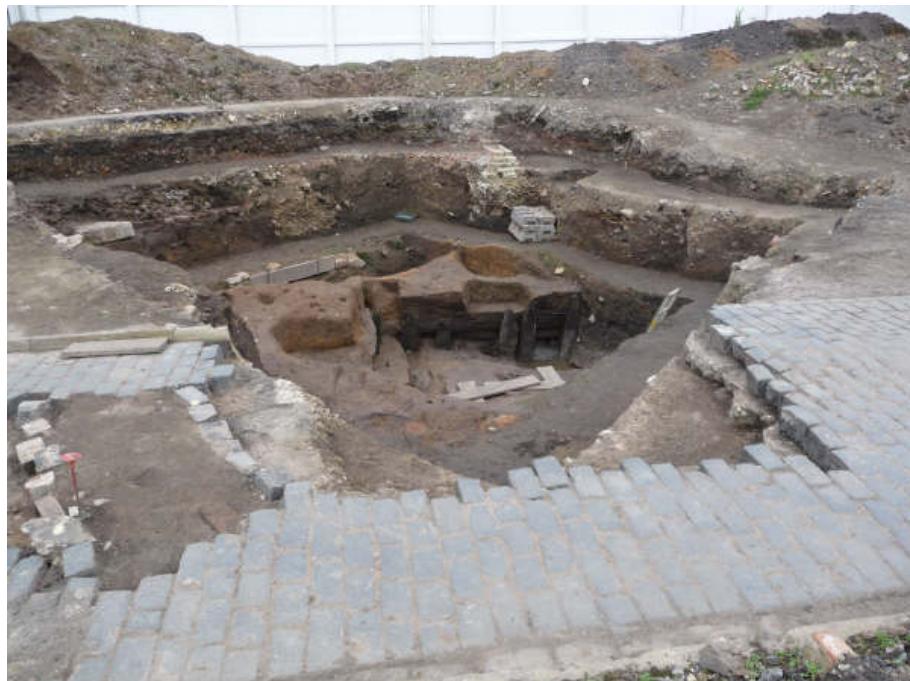
Hungate site, and building.

If you have been to Hungate before you will have seen the remains of the Victorian street, Haver Lane, running through the site. Just behind this street, in the left hand corner of the site, the remains of a Viking age cellared building have been found. Until now it's been impossible for anyone on tours to see into the hole the YAT team have wedged themselves in, but due to the discovery the concrete walkway in place at the excavation has been specially extended to provide a view of the Viking house for the public, a view which is impossible from any other angle. The house found at Hungate is very similar in style to those found at Coppergate, seen at the Jorvik. Without dating the timbers from Hungate that are currently still in situ, the house's date isn't completely

The cellar is dug into the ground and re-enforced with horizontal wooden planks and then braced by larger wooden posts. One of the walls is also re-enforced with an earthen bank, another thing not seen in the houses at Coppergate. The cellar could have been over 5 foot in height and appears to have two phases of building although the second was still very early on in its construction. It was extended around 40cm and this appears to be due to a patch of soft ground found in one corner of the cellar. The use of the cellar is not completely certain; it could have been a workshop or a storage space but some of the other finds also suggest it could have been a domestic dwelling.
